COMPARISON OF PROPOSED SLOPE FAILURE ANALYSIS AT LATAR EXPRESSWAY SELANGOR WITH PREVIOUS CRITERIA AND INDUSTRIAL STUDY

SEGI University, Faculty of Engineering and the Built Environment, Jalan Teknologi, Kota Damansara, 47810 Petaling Jaya, Selangor, Malaysia

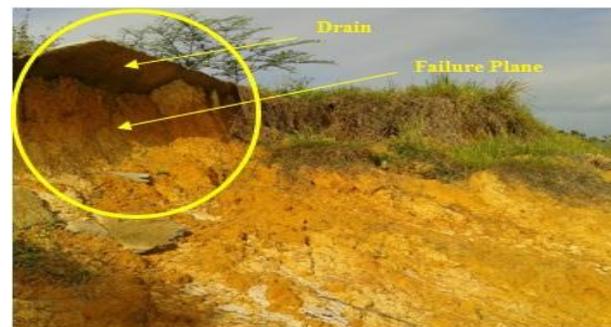
Fig. 3: Failure Plane beneath Slope Crest

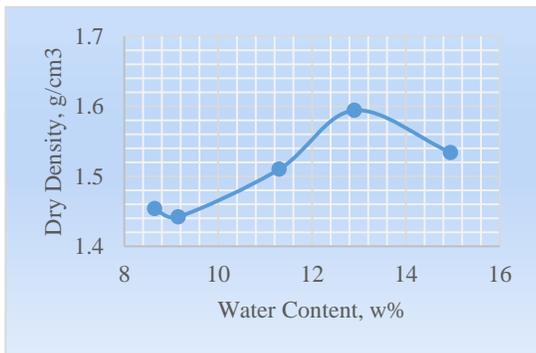
Fig. 5: Maximum Dry Density – Stable Slope

was found in the failed slope samples thus its strength is sufficient if kept dry but may reduce significantly upon high water penetration, although this may not have happened if the drainage system was maintained as instructed in [11]. The Plasticity Index (PI) of soil samples at the failed and stable slopes is 13 and 19 respectively. Higher plasticity index indicates that the soil is less permeable as stated by [13] thus it can be deduced that the stable slope is less susceptible to rain penetration making it more resistant to saturation. In terms of compaction strength, the samples from the failed slope achieved a maximum dry density of 1.7 g/cm^3 at 15% water content, it exceeded the maximum dry density of 1.6 g/cm^3 at 13% water content for sample from the stable slope as shown in Figure 4. The results of literature review were used as a base reference for evaluation which is summarized in Table 1. Both samples passed the Clevenger's and Yue's criteria, however the stable slope samples have shown higher collapse potential than the failed
